Investigating the accelerated test condition to produce cracking failure of water ballast tank coatings

N. Perera¹, E. A. Oriaifo¹, A. Guy², P. S. Leung¹, K. Tan¹

Key words: Corrosion, Hygrothermal cycling, Test protocols, Water ballast tanks.

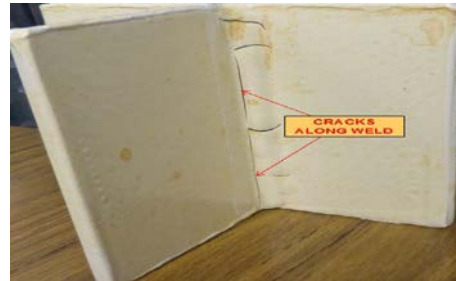
For formulation A, after just 1 accelerated test cycle, cracks were observed only on the welded joints at the intersection of the flange and web of the T girder as shown in Fig. 2. All 6 T girder test specimens for both dfts for this formulation exhibited cracks at this location.

Fig.2: T girder test specimen for formulation A displaying cracks along the welded joint

cycles. Cracks at this location were observed on a total of 2 T girder test specimens having 640 μm and 960 μm dfts respectively. The size of cracks that appeared on the welded joints at the intersection of the flange and web of the T girder ranging from largest to smallest has been observed in rank order of Formulation A, B, C and D. The number of accelerated tests cycles that were required to produce cracks on the welded joints at the intersection of the flange and web of the T girder ranging from the lowest (1 cycle) to the highest (59 cycles) were also observed in rank order of Formulation A, B, C and D. From these observations it can be deduced that the coating cracking resistance strength ranging from weakest to strongest is in the rank order of Formulation A, B, C and D.
